**United States Air Force
611th Civil Engineer Squadron**

**Remedial Investigation Report
Galena Airport and Campion Air Station**

Volume 1—Text

March 1996

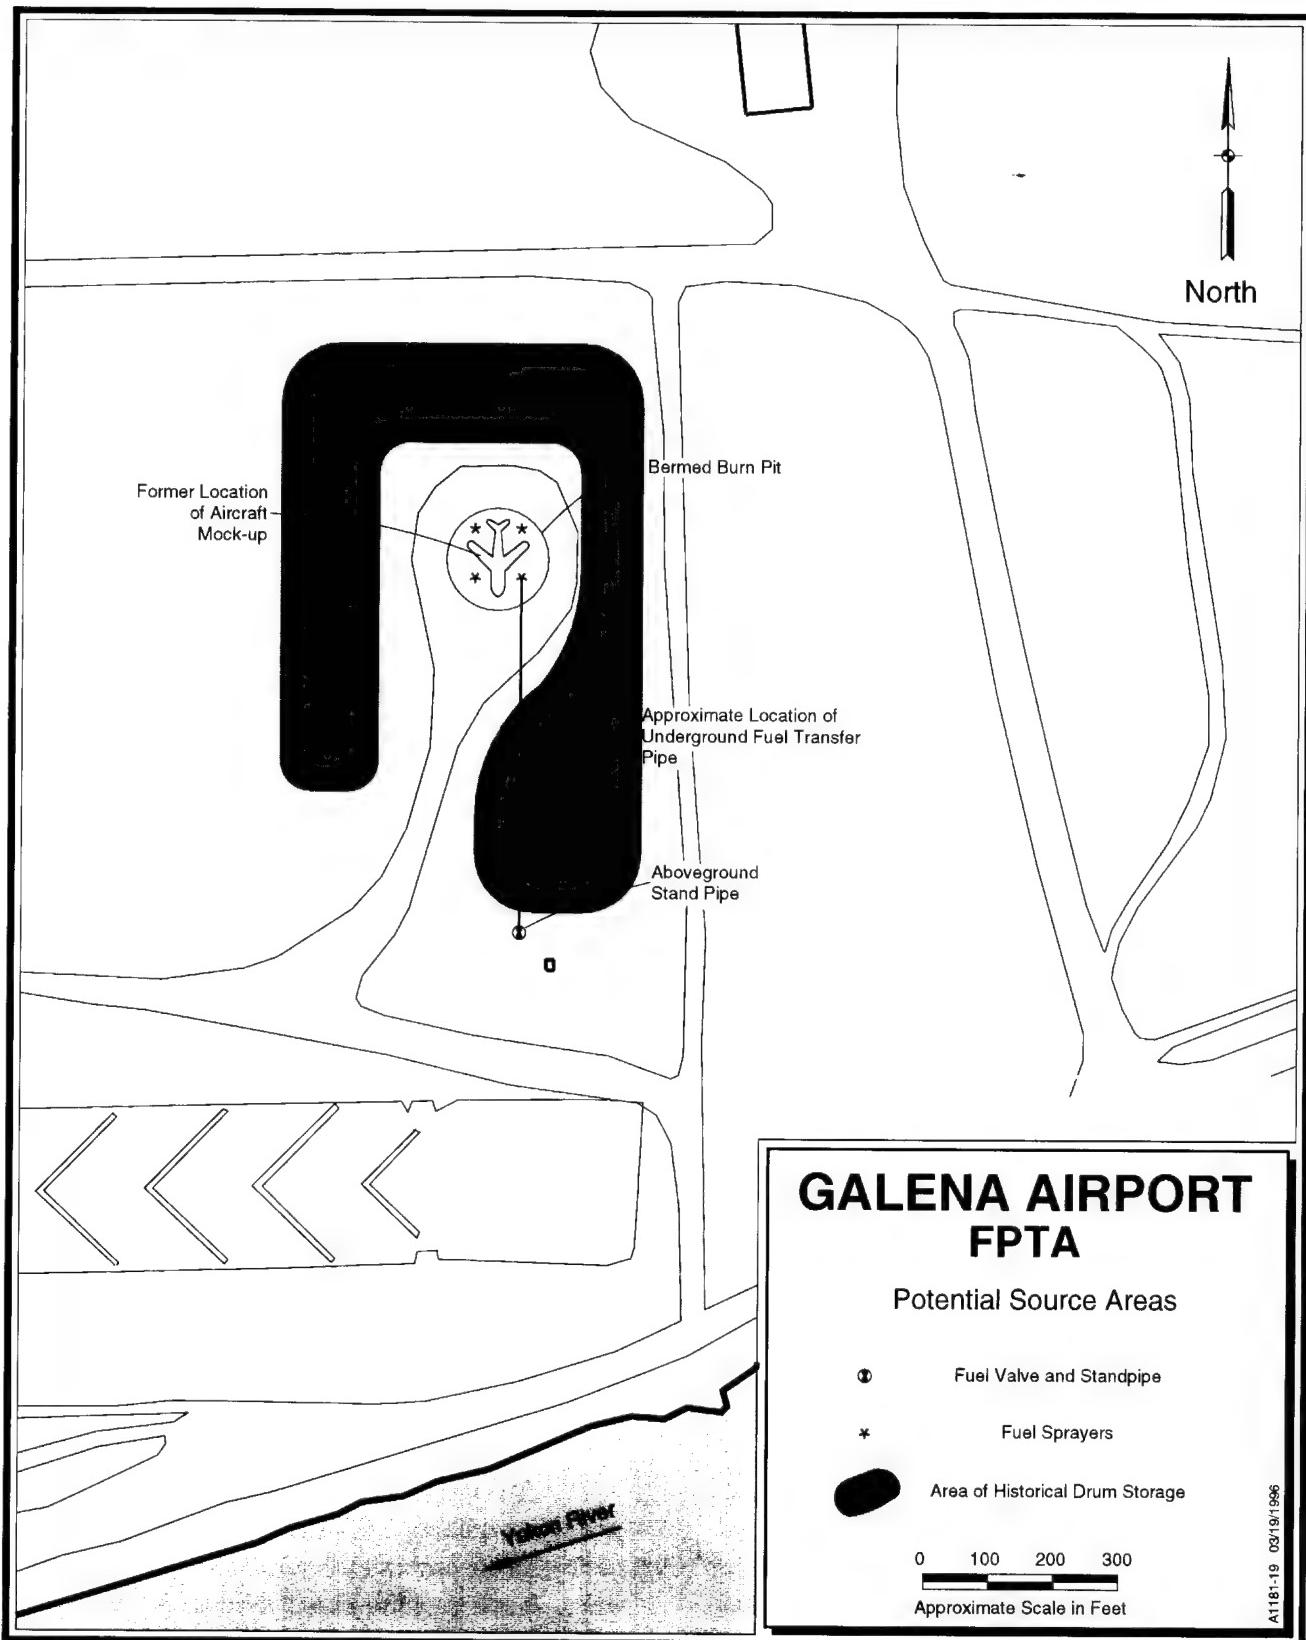
Figure 3.2-2. Location of Former Potential Source Areas at the Fire Protection Training Area (FT001)

The results of the RI suggest that past fire protection training activities at the FPTA have resulted in the contamination of soils and groundwater. A soil gas survey conducted across the site in 1993 identified two distinct areas of potential

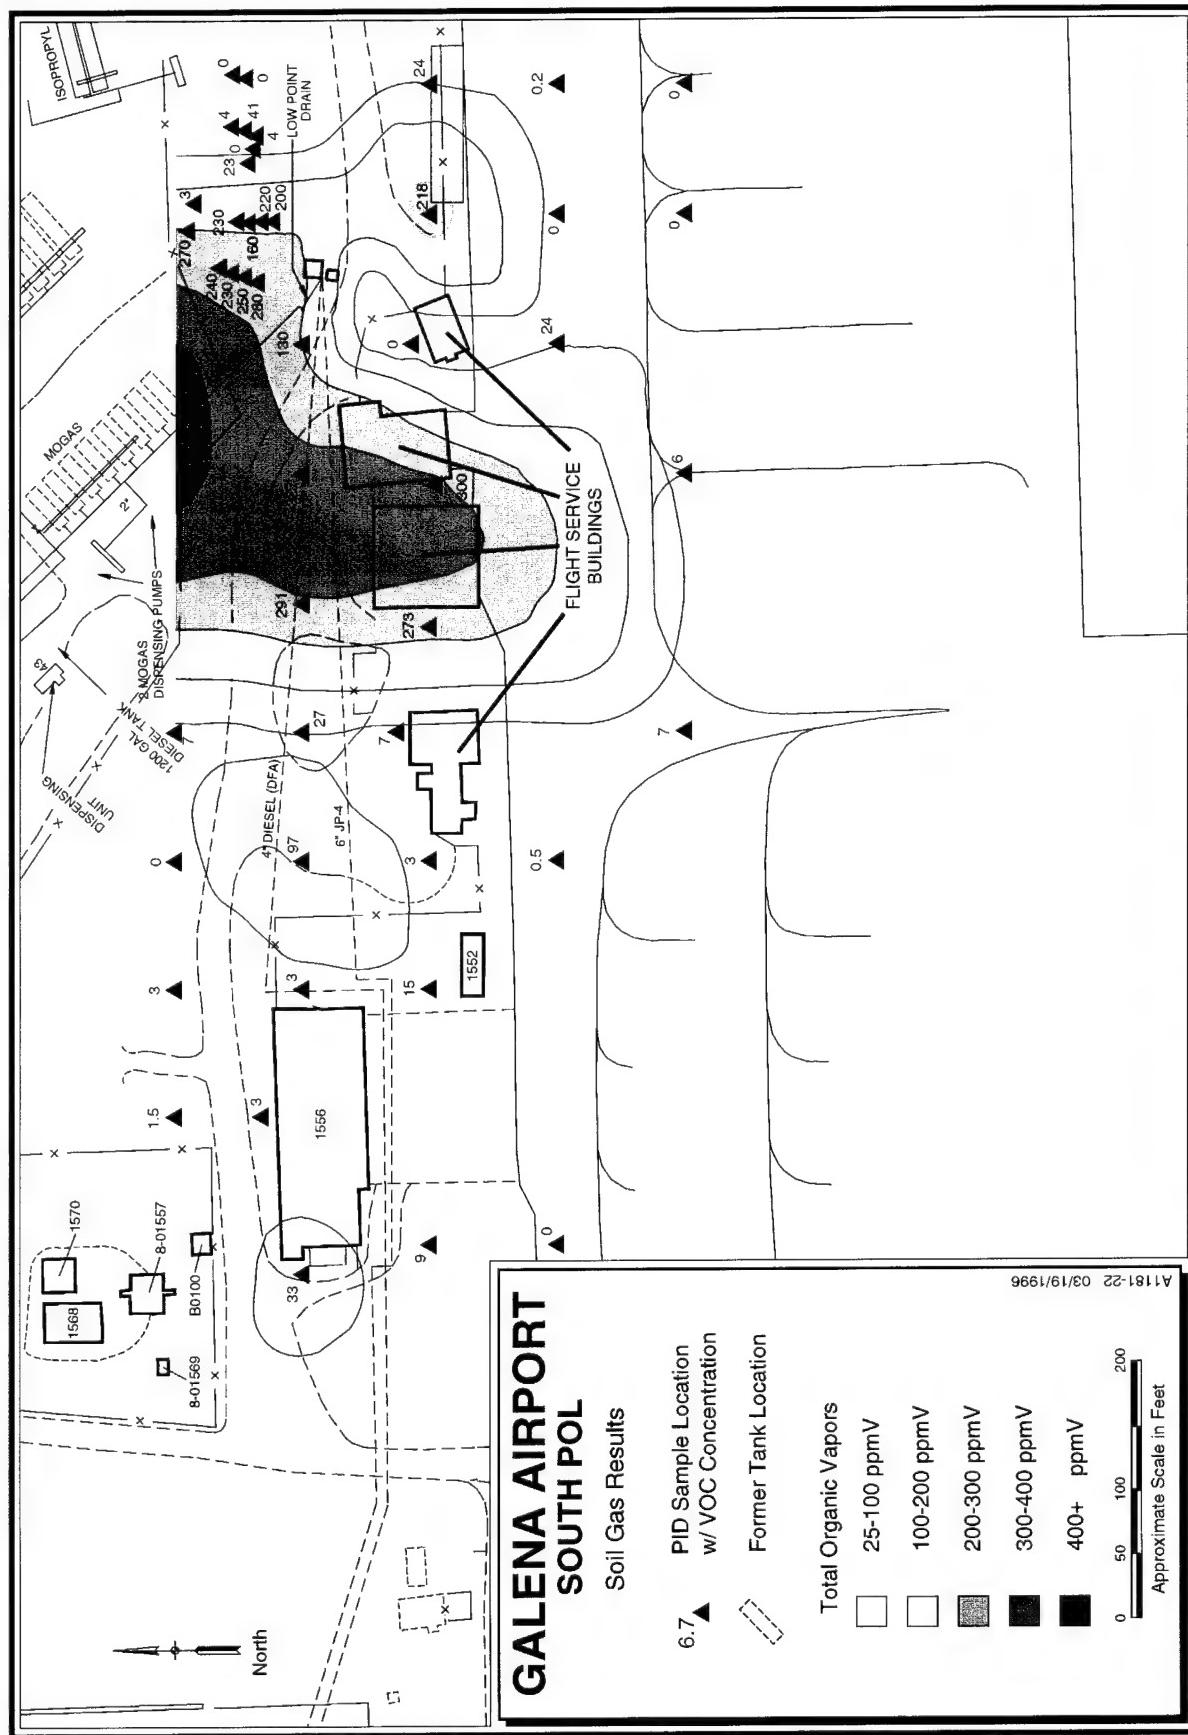
Figure 3.3-5. Soil Gas Survey Results for the Southern POL Tank Farm Area (ST005)

No discrete sources could be distinguished in the southeast POL Tank Farm using the soil gas results. It appears that the horizontal and vertical movements of the water table may have obscured any individual source areas. Data from 31 soil gas samples, presented in Figure 3.3-5, indicate that two lobes of elevated soil gas concentrations extend southwest from the POL Tank Farm past the air services buildings. The area between these lobes includes portions of the TS site where soil borings encountered ice lenses. These areas of permafrost may be blocking contaminant migration or interfering with soil gas measurements. Soil gas data collected by the 11 CEOS in 1993 (not shown in Figure 3.3-5) show similar distribution patterns. The soil gas results shown in Figure 3.3-5 indicate two smaller areas of hydrocarbon contamination in the southern part of the POL Tank Farm. One area is just west of Building 1556 (the fire station), and the second is north of the Tanana Air Services building. The source of organic vapors detected in these areas is uncertain. The low levels of organic

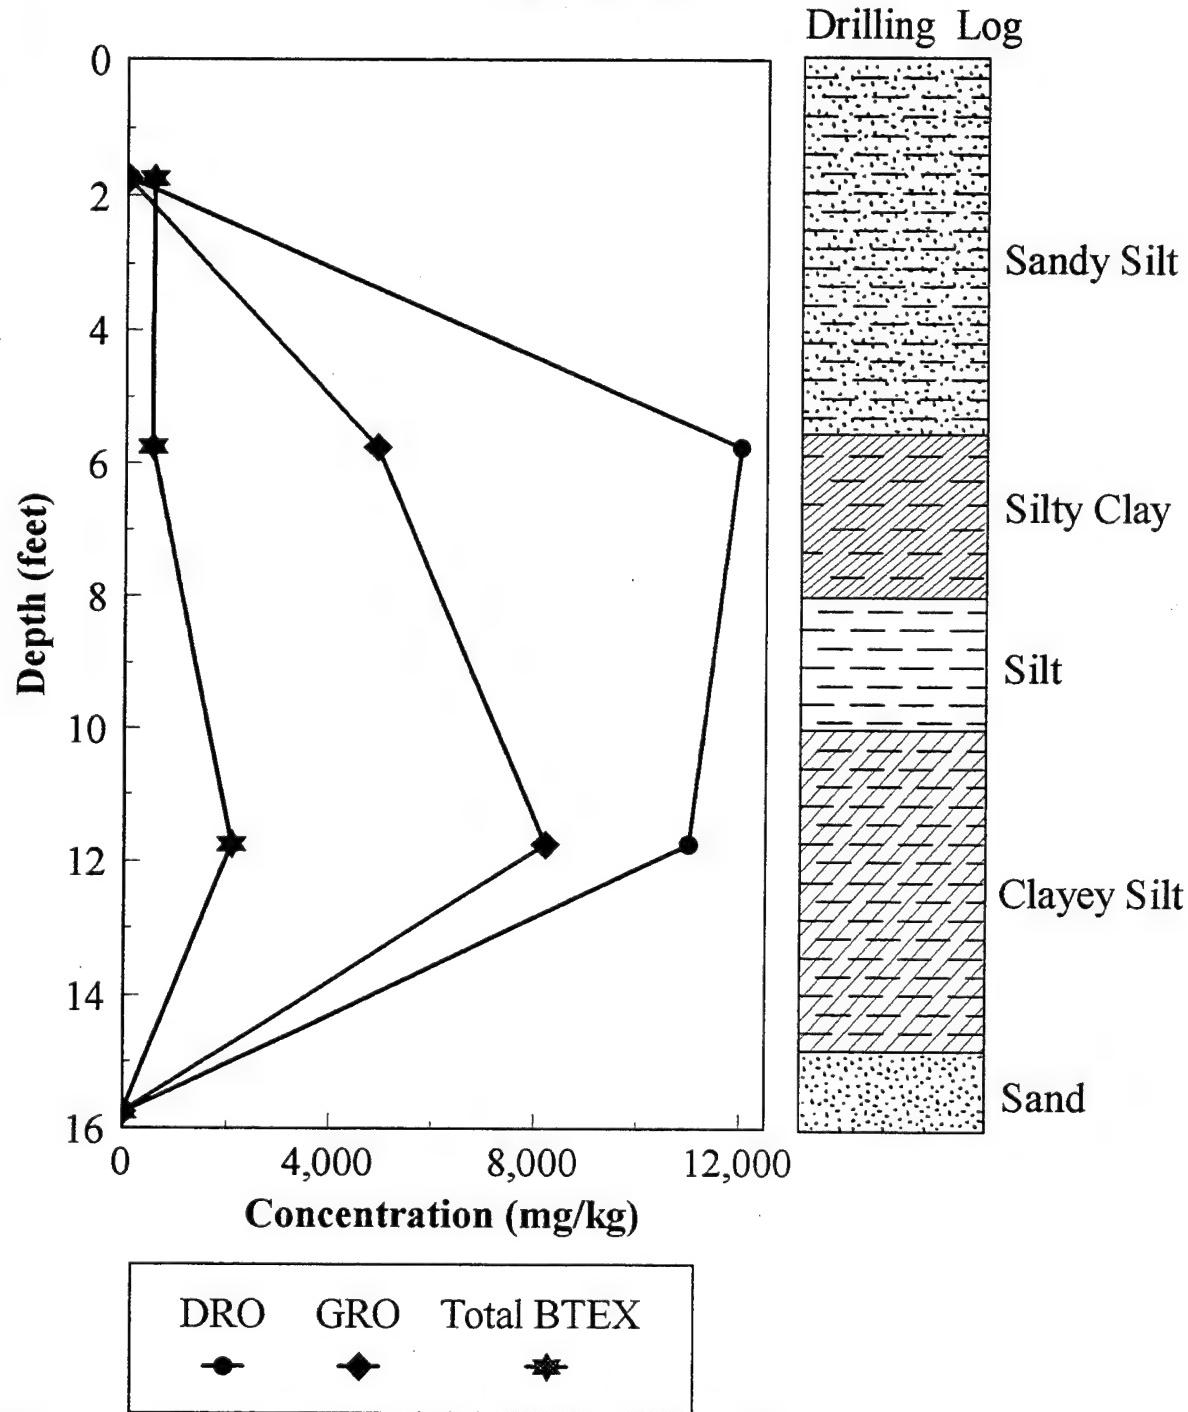
Figure 3.4-8. Concentrations of BTEX, DRO and GRO vs. Depth in Soil Boring 06-SB-03 at the Building 1700 Source Area

One soil boring, 06-SB-03, was placed at the southwest corner of Building 1700 to further investigate the nature and vertical extent of the contamination identified by field screening activities. The results, summarized in the attachment to Section 3.4, indicate the presence of fuel-related contaminants. Benzene and total BTEX concentrations gradually increase with depth up to 12 ft bgl. From the surface to approximately 10 ft bgl, the concentrations of BTEX compounds exceed the screening criteria; from approximately 4 to 10 ft bgl, DRO and GRO exceed the screening criteria. At depths of 14 to 16 ft, the contaminant concentrations drop sharply, indicating limited vertical migration. The changes in BTEX, DRO, and GRO concentrations with depth are shown in Figure 3.4-8.

The field screening and analytical results at this site indicate the presence of fuel contamination from a subsurface source that is separate from the Building 1845 source area. This contamination probably originates from the dry well and waste oil tank associated with Building 1700.

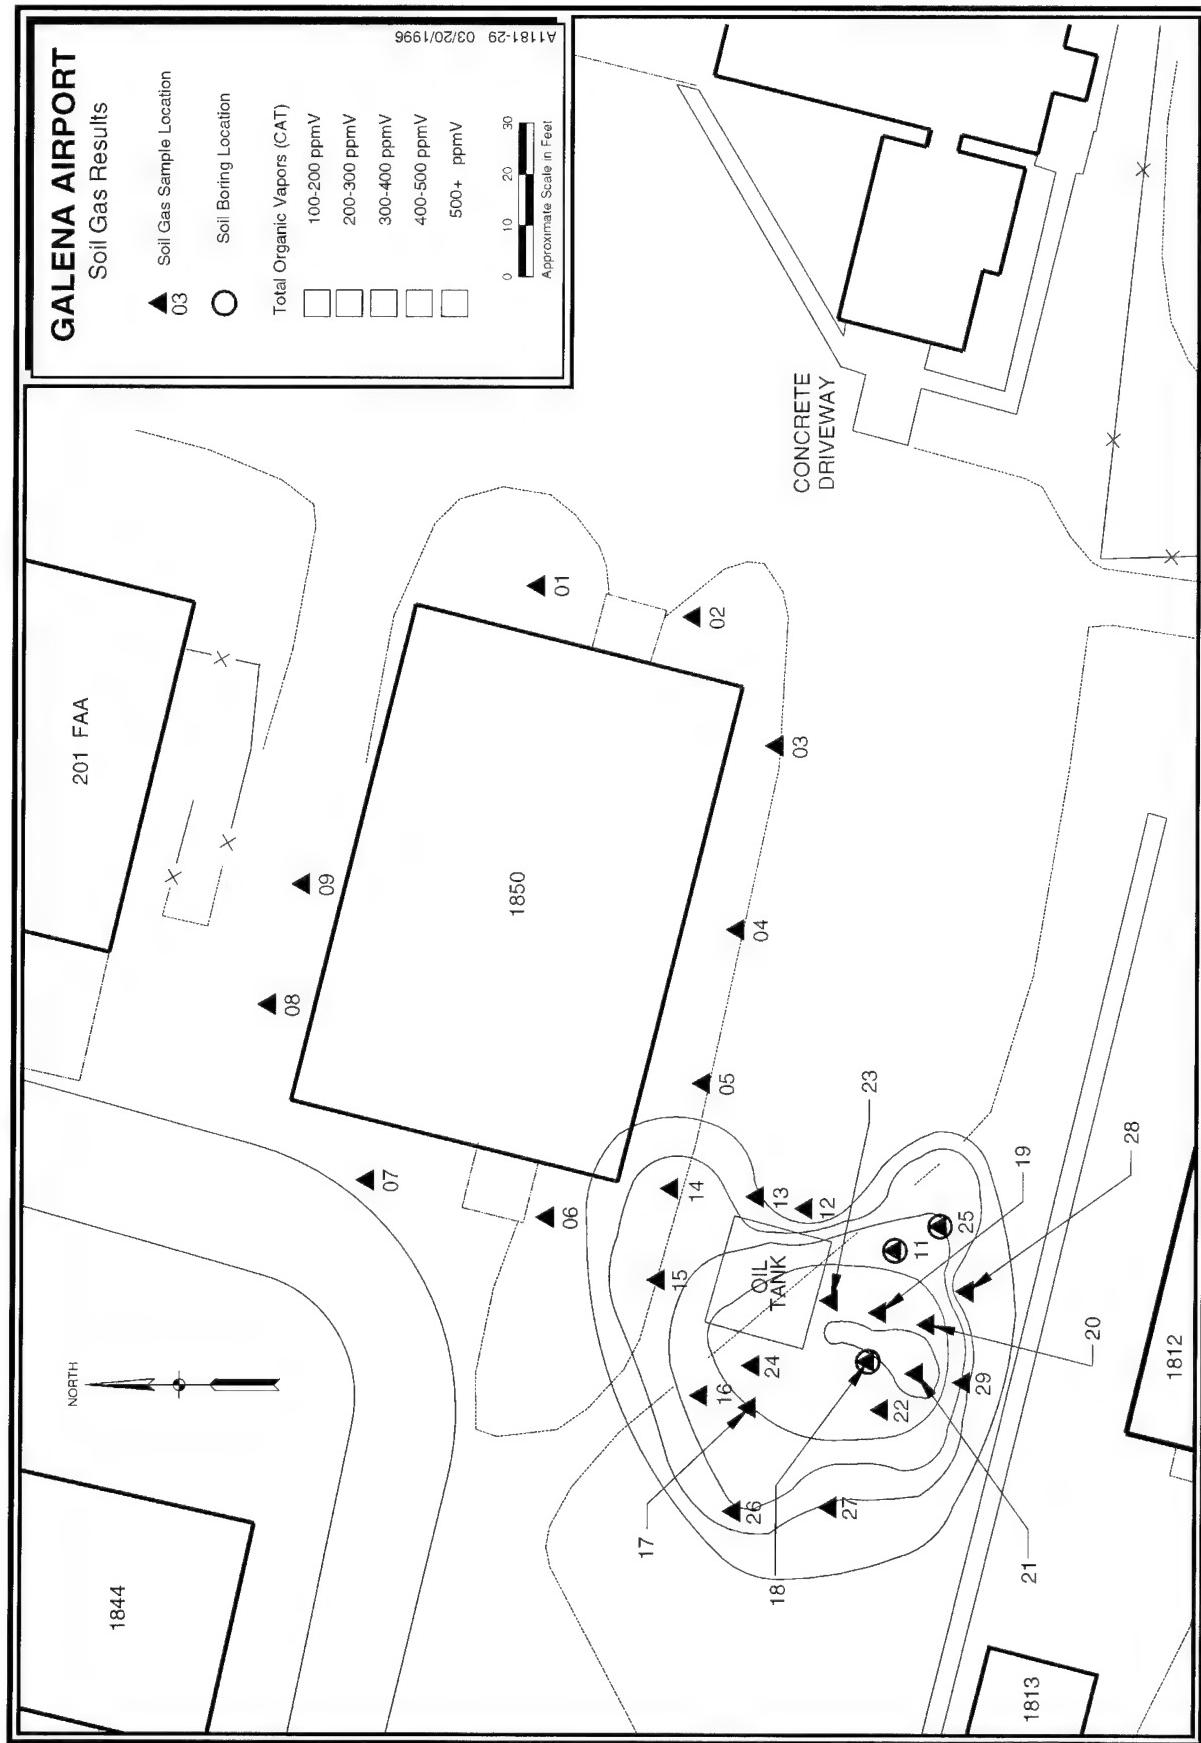
Figure 3.4-9. Soil Gas Survey Results for the Building 1850 Source Area

The area of petroleum contamination at Building 1850 is approximately 30 ft in diameter, as indicated by soil gas concentrations greater than 200 ppmV. The soil gas and AH/TPH data suggest that this spill may be weathered. In newer fuel spills, both saturated and unsaturated hydrocarbon compounds typically occur. Over time, the residual, or saturated, hydrocarbons are left while the unsaturated, or aromatic, hydrocarbons are volatilized or leached away. Neither the nature nor the source of these hydrocarbons is known, and no spills or leaks have been reported for this location.

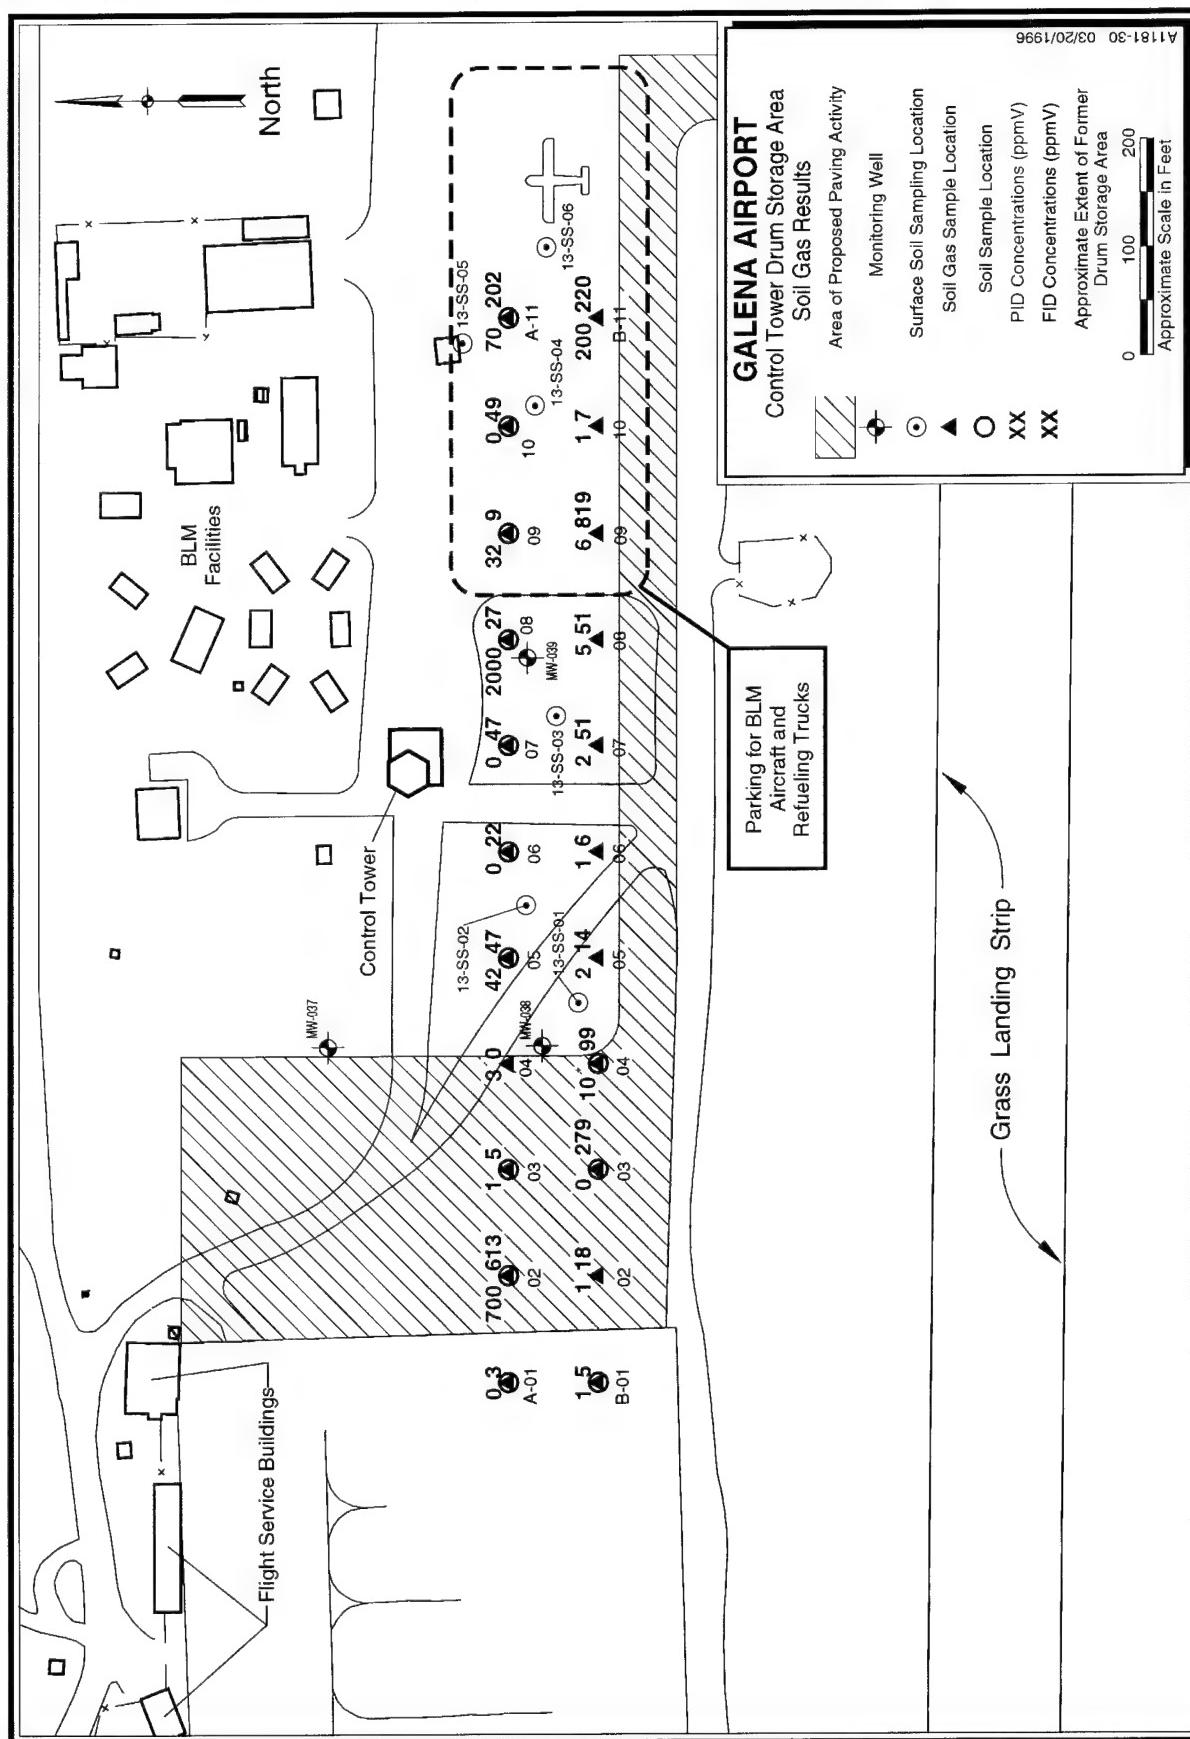
Figure 3.5-1. Soil Gas Survey Results for the Control Tower Drum Storage Area South (SS013)

The surface soil samples were generally made up of gravelly sand fill. No staining or odor was evident in the samples except for the one collected at location 13-SS-06. The soil at this

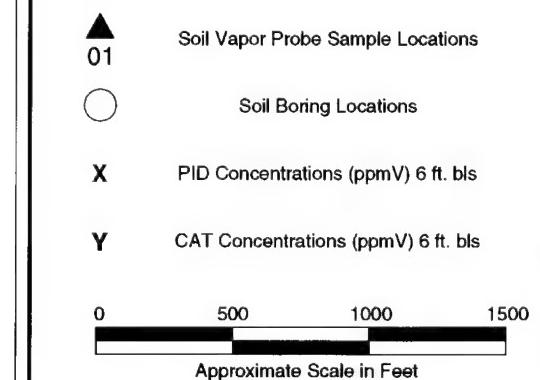
**GALENA AIRPORT
DRUMS, PERIMETER DIKE**

The low levels of TPH measured in soils from around the dike do not constitute a potential source of contamination. Therefore, it is recommended that this source area be removed from consideration at Site SS007. Following completion of the drum removal activities being conducted north and west of the Galena Airport installation, an NFRAP decision document should be prepared for this site.

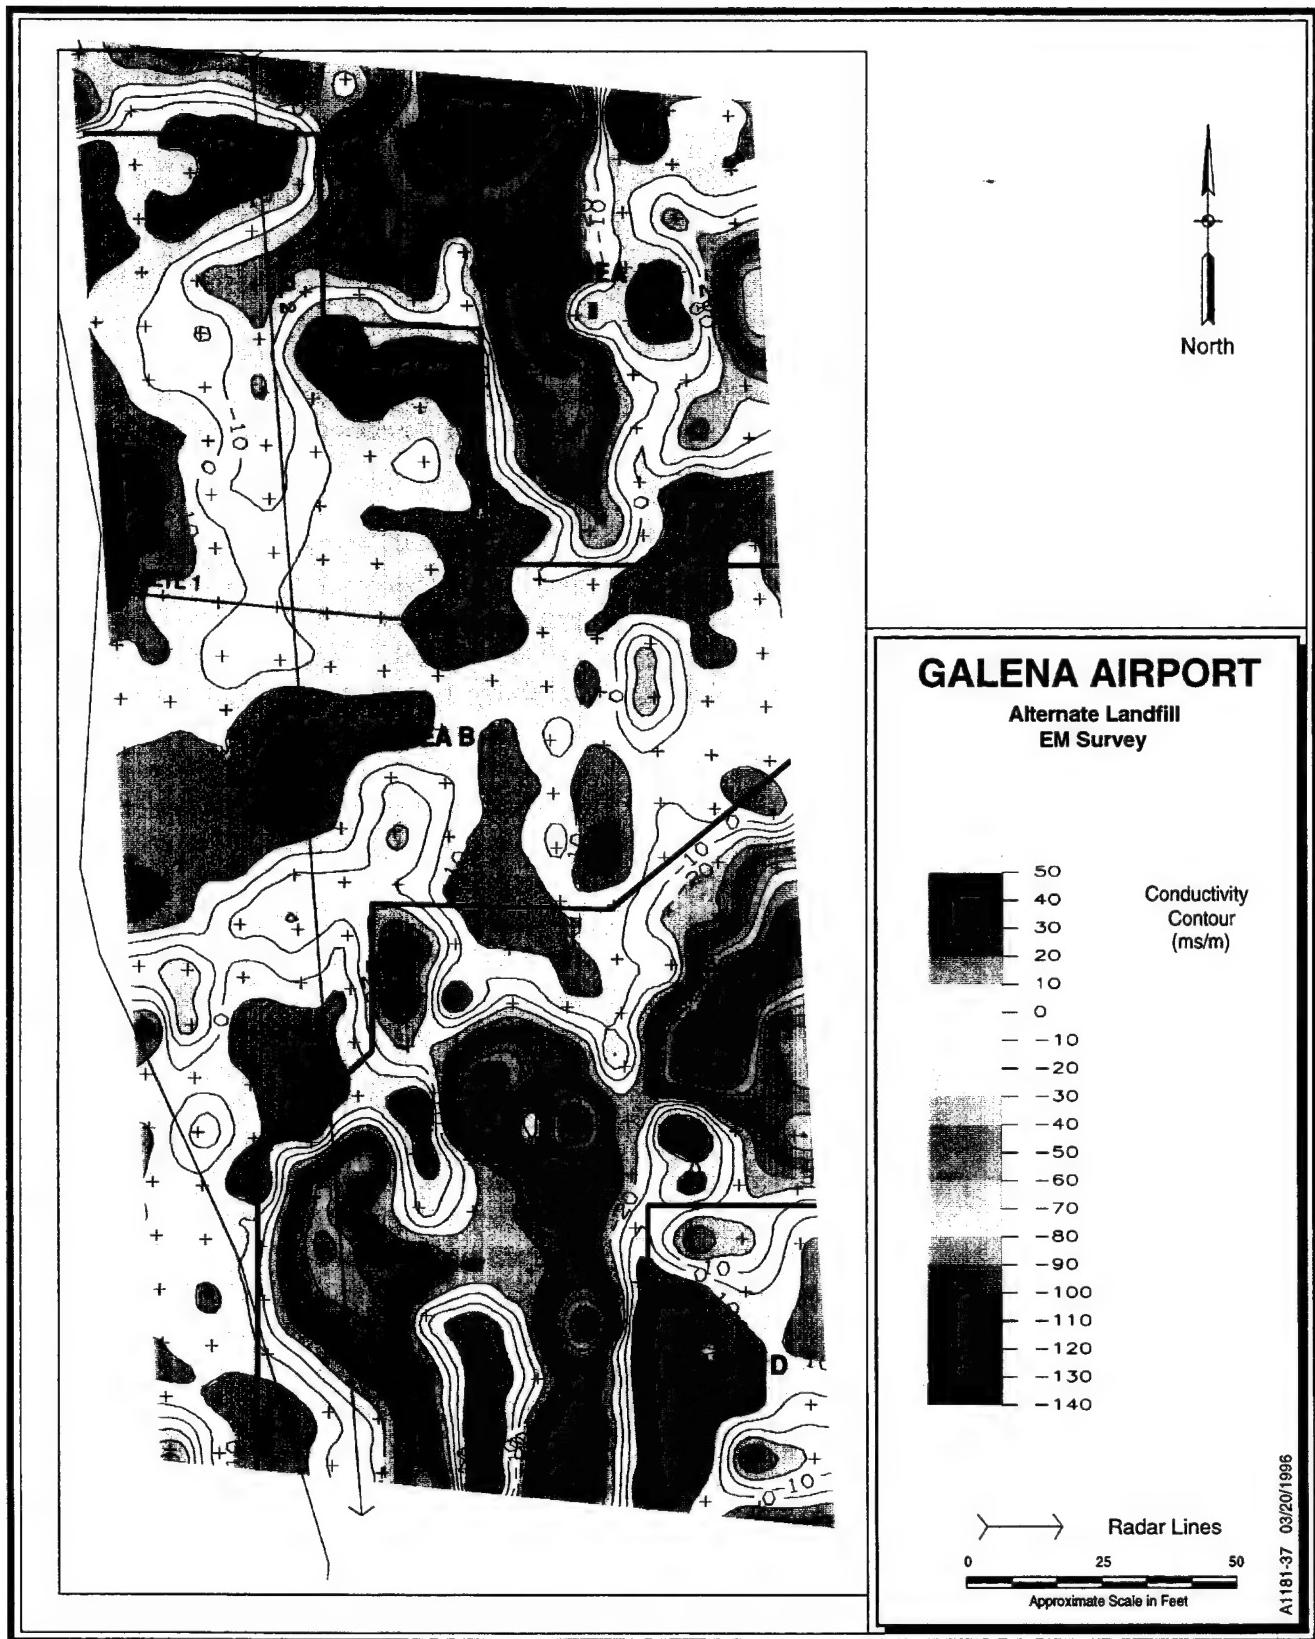
Figure 3.8-1. EM and GPR Contours at the Alternate Landfill

The EM and GPR surveys identified several areas that potentially have buried metallic objects. Figure 3.8-1 also shows contour maps of the ground conductivity data collected at the Alternate Landfill. Two main areas of EM anomalies were defined by the surveys, one in the north-

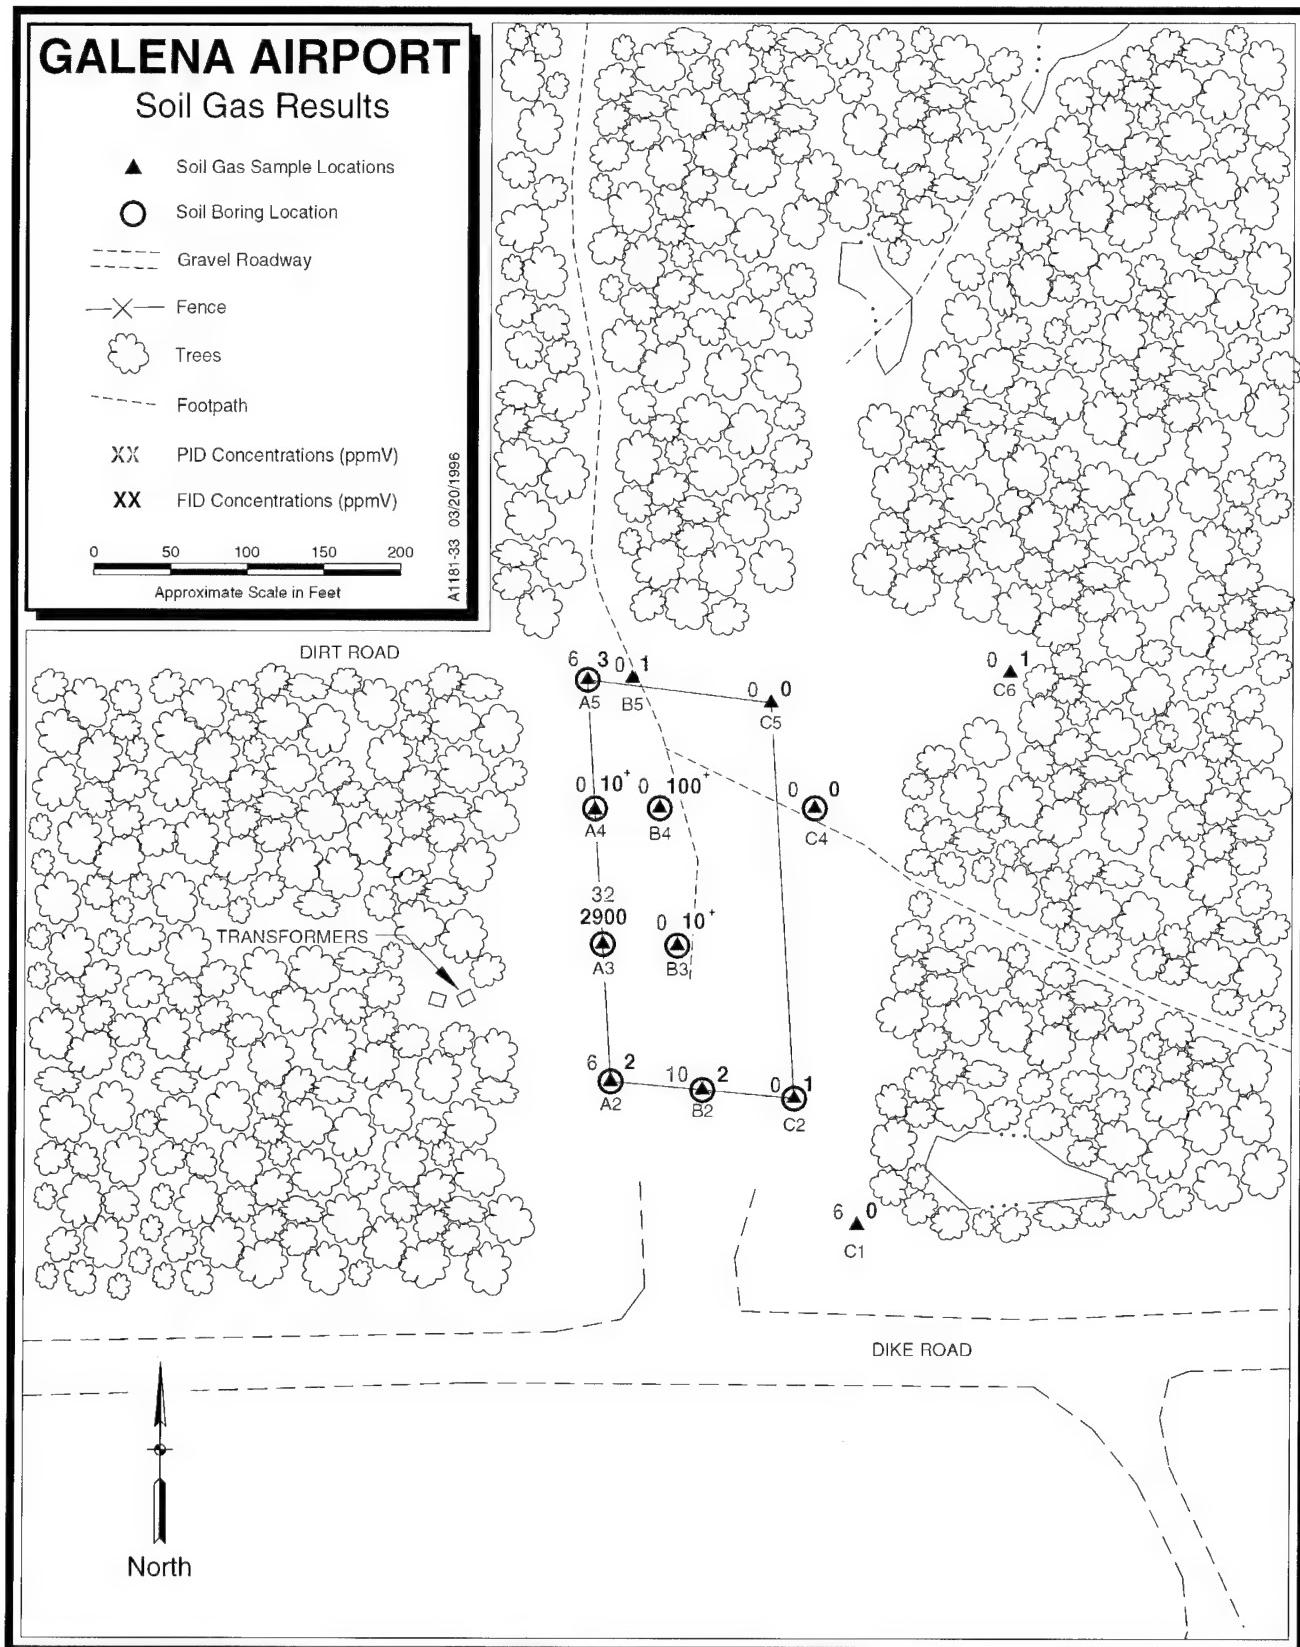
Figure 3.8-2. Field Screening Results for the Alternate Landfill

Soil gas/soil sample field screening was performed at the Alternate Landfill after the data from the geophysical survey were reviewed. Figure 3.8-2 shows the results of the PID and FID screening and soil screening results are shown in Table 3.8-1. The highest readings were generally in the south and west side of the site. The PID/FID readings generally indicate that the highest soil gas concentrations are located near the middle of the site, but the data are too sparse to contour. TPH were detected at all locations sampled, ranging from 2 to 24 mg/kg, with the exception of a peak of 506 mg/kg at location A-2. AH were detected only at three locations.

The aerial photographs indicate that the Alternate Landfill has been in use as a disposal site since at least the mid-1960s. This site is still used to dispose of food wastes and as an alternate dumping location when the main landfill is flooded. The investigation indicates that metallic waste and, potentially, petroleum sludge wastes have been disposed of at this location. The reference to the Sludge Disposal Area on the 1965

drawing suggests that this area may have been used to dispose of the sludge from storage tank cleaning. All of this information is consistent with recorded field observations and the results of field screening.

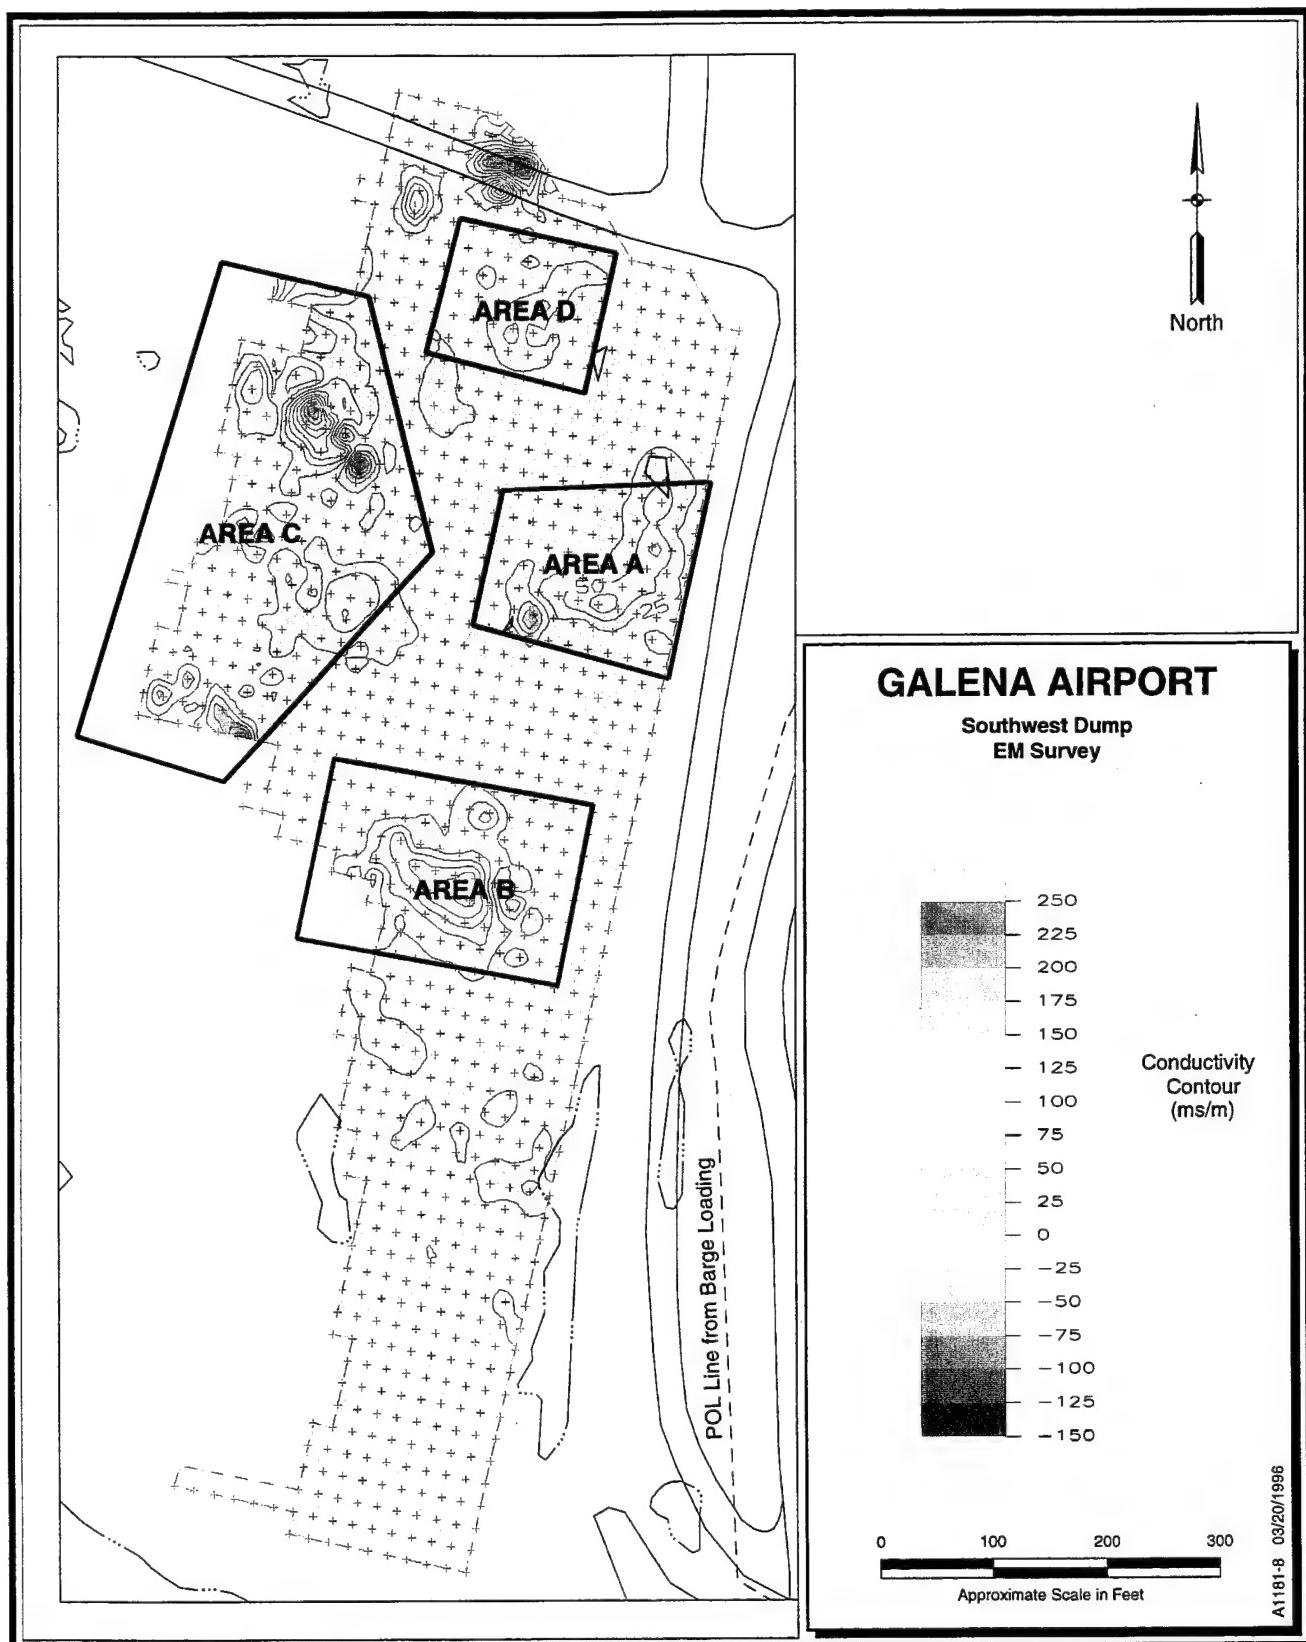
Figure 3.8-3. EM and GPR Contours at the Southwest Dump

The anomalies in Areas C and D are interpreted to be caused mostly by metallic objects.

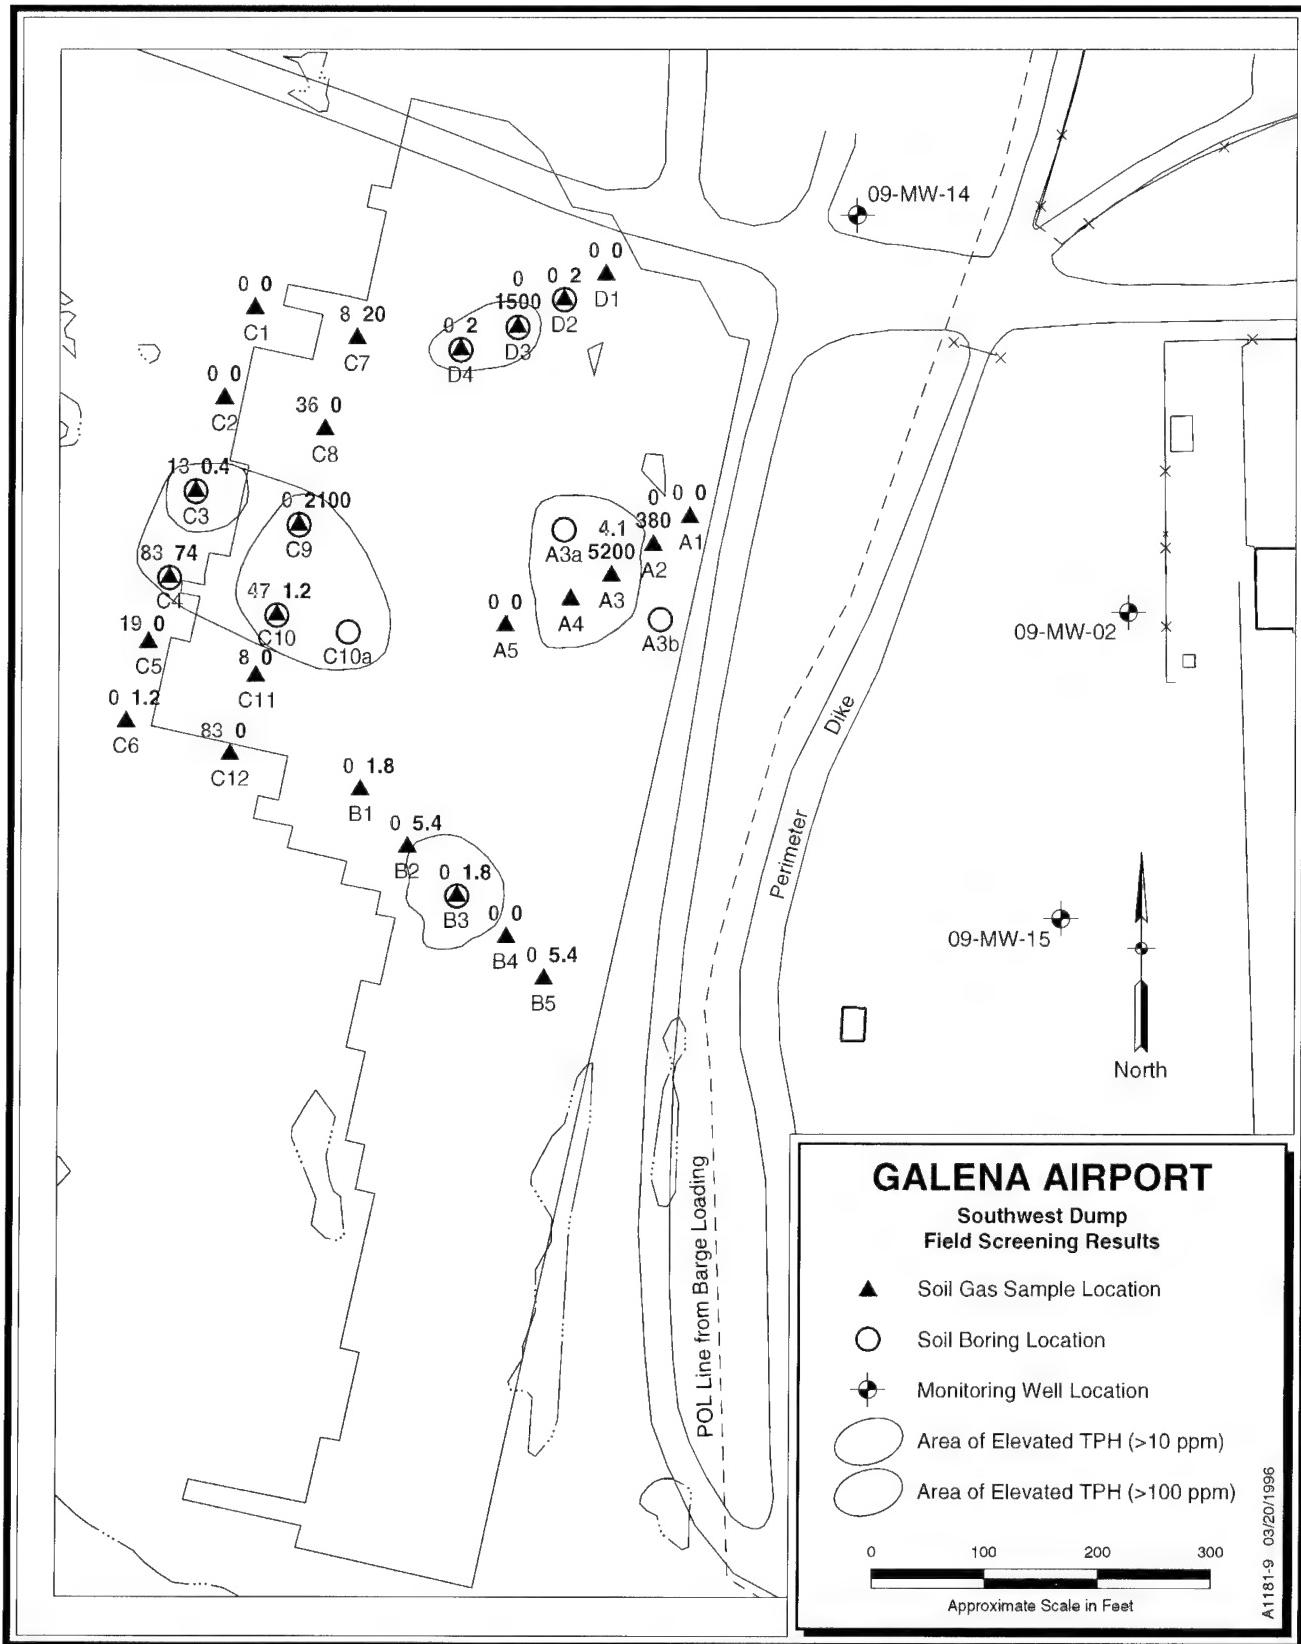
Figure 3.8-4. Field Screening Results for the Southwest Dump

The results of the soil gas/soil sample screening survey are presented in Figure 3.8-4 and in Table 3.8-2. Soil gas readings were taken with both a PID and a FID analyzer, and soil samples were analyzed for AH and TPH with a field IR analyzer. The locations of the EM grid and soil gas/soil sample screening points are shown in Figure 3.8-4.

The aerial photographs show a staging area for drums adjacent to these anomalies, and the in-phase data from the EM survey indicate that the anomalies are predominantly from metallic objects. The GPR lines over these areas show reflections that are also indicative of metallic objects. The TPH, AH, PID, and FID readings also indicate that hydrocarbon contamination has taken place in these areas. This contamination is probably the

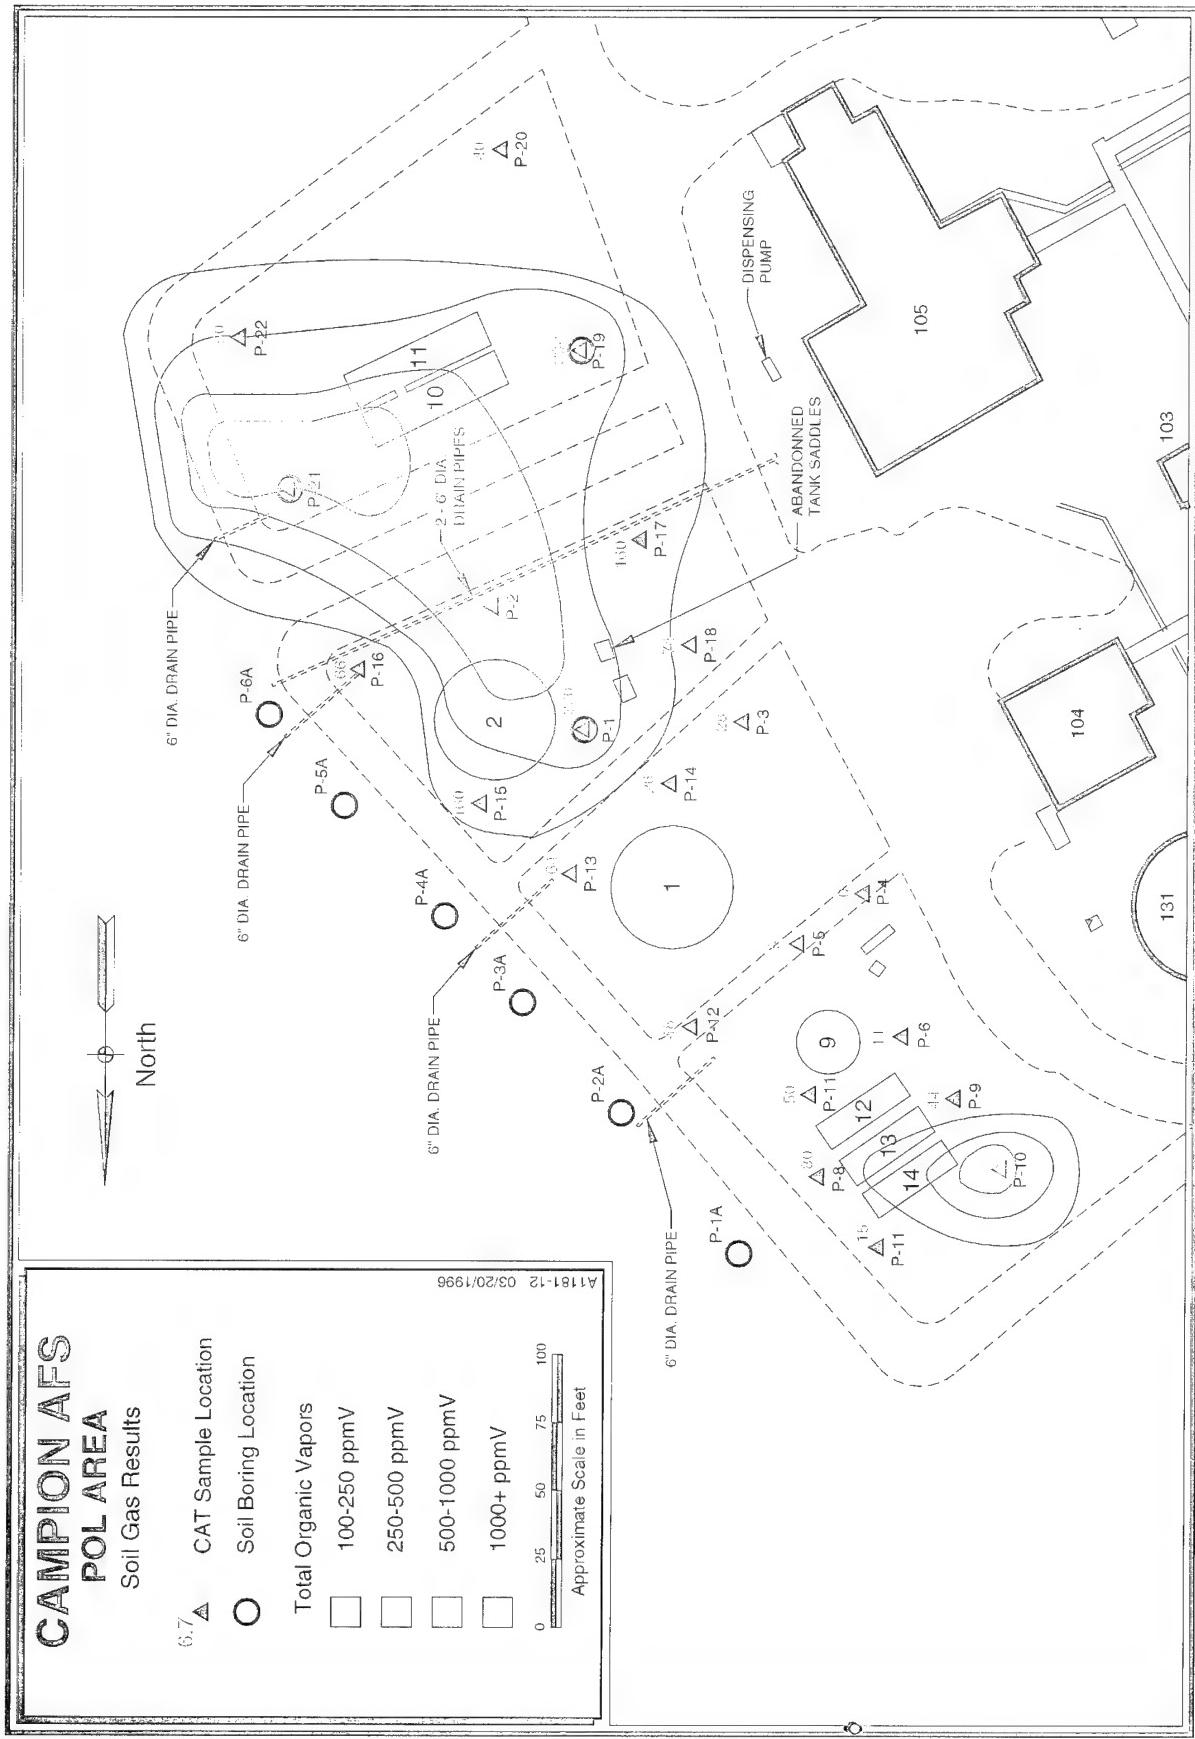
Figure 4.2-3. Soil Gas Survey Results for the Campion POL Area (ST007)

During the 1992 field season, two sediment samples were collected in the drainage to the east of the POL. In 1993, five additional sediment samples were collected to further define the extent of off-site migration. These samples were collected along the drainage beginning 200 ft downgradient of the farthest downstream sample collected in 1992 and continuing every 200 ft for 1,000 ft (see Figure 4.2-1). Some of the soil and sediment samples were found to contain elevated concentrations of GRO and/or BTEX compounds,
